**POST INSPECTION MEMORANDUM**

Operator Inspected: Northwest Pipeline Corp (WGP) OPID: 13845 Region: Western

Inspection Type: O07 - Team Integrity Management Program (IMP) Inspection

Inspection Dates: 4/29/2012 through 5/4/2012 and 5/14-18/2012 (TX and UT) Assign # 108415

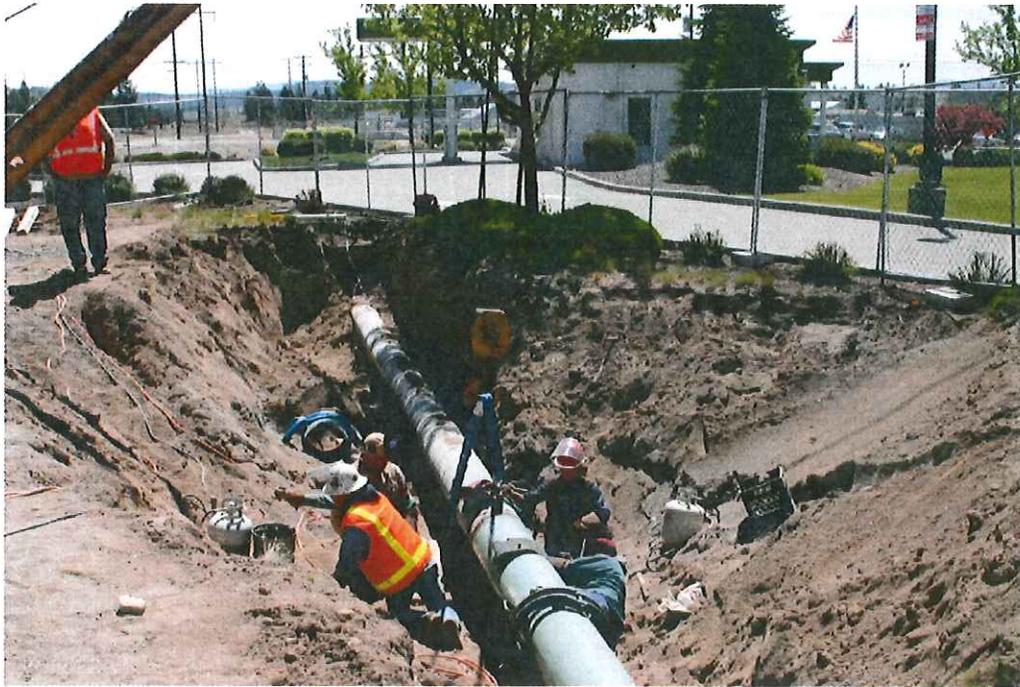
The portion of unit inspected includes the main replacement in North Spokane, Washington between Nine Mile Falls and Spokane Mead Meter Stations, about 5.6 miles, 16-inch diameter, 0.250” wt, API 5L X52 pipe with Epoxy coating minimum 17 mils. The welding procedure and its qualification were reviewed at the Spokane District Office in accordance with Williams welding procedure and qualification of procedure (WPS No. SM G 2 and PQR No. SMAW-6301). The welders qualification from Snelson Construction and two NDT technicians from Quality Integrated Services were reviewed. Viewed NDT film for girth welds XR -69, -70, -71, -72, -73, -67, and repaired weld XR 67-R1. Reviewed 61 girth weld evaluated by NDT technicians. No concerns were noted in the procedure, qualification, or field data.

Exhibit B - Spokane, WA  
Class 3 Location – 16-inch line replacement  
Photo: Al Jones 6/6/2012
