UTILITIES AND TRANSPORTATION COMMISSION

**RE: Natural Gas Incident Investigation: 900 SW Holden St., Seattle, Washington,
March 4, 2016 (Insp. No. 6909)**

UTC Incident Investigation Form

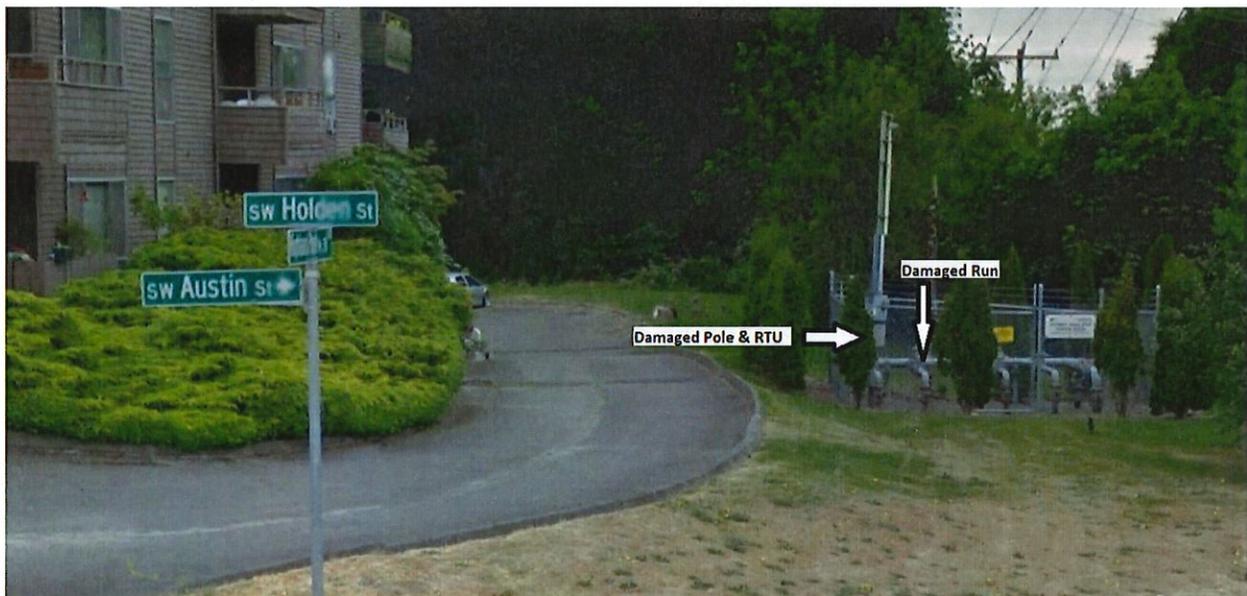
According to a representative from PSE, at the time of installation, this station was reviewed and determined not to be subject to anticipated vehicular damage. The criteria in section 6 of GOS 2525.3700 were considered; documentation of the consideration of these factors is not required by the operating standard. The station was located approximately 50' from the nearest roadway and surrounded by a fence. It was further surrounded by a hillside to the east, a utility pole to the southeast, and a building to the west. Therefore PSE concluded that the station was not subject to anticipated vehicular damage (see photo).

Photo 2: Street View of Regulator Station

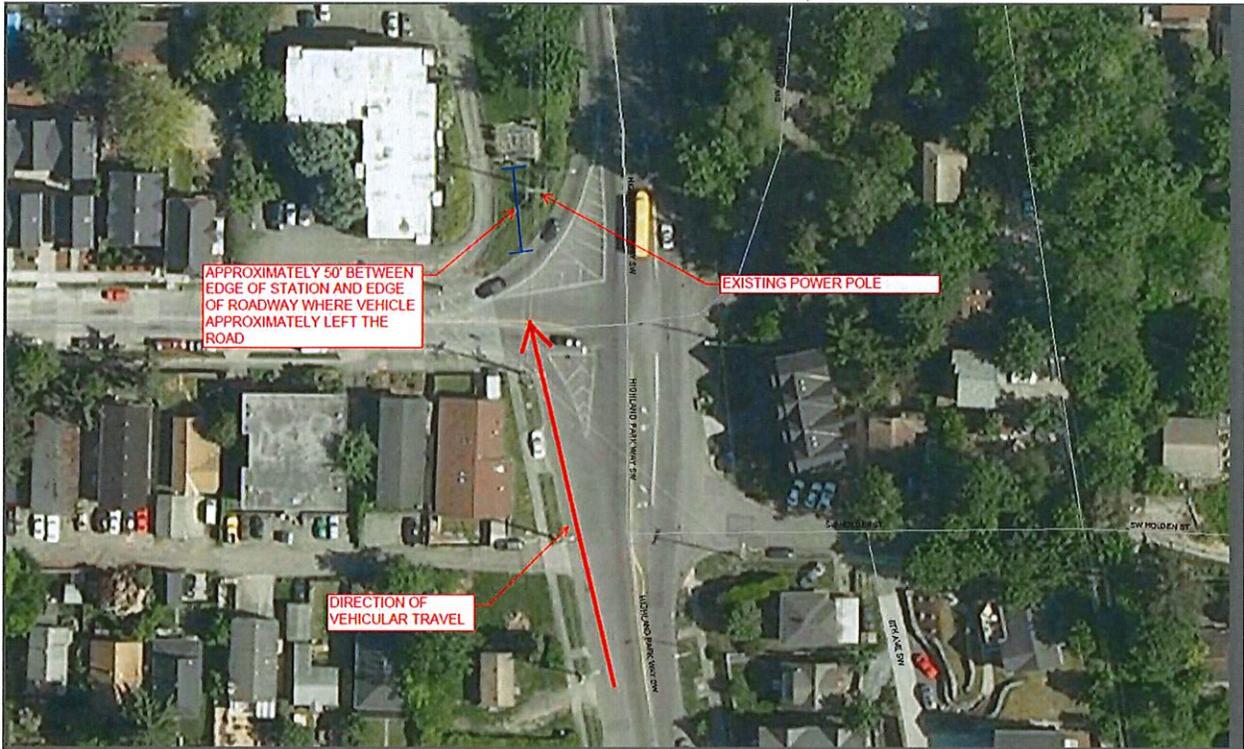
The release of gas was caused by an outside force, a driver under the influence of alcohol, driving a car travelling north on 9th Ave SW at a high rate of speed smashed through the fence of a PSE district regulator station damaging the outlet intermediate pressure regulator run of the station. The Remote Telemetry Unit (RTU) within the station was also impacted. The damaged 6" diameter steel pipeline was operating at an MAOP of 45psig at the time the damage occurred. Two sensing lines were also replaced on two different runs of the regulator due to the vehicle damage.

Photo 3: Path of Vehicle That Damaged Regulator (Photo provided by PSE)

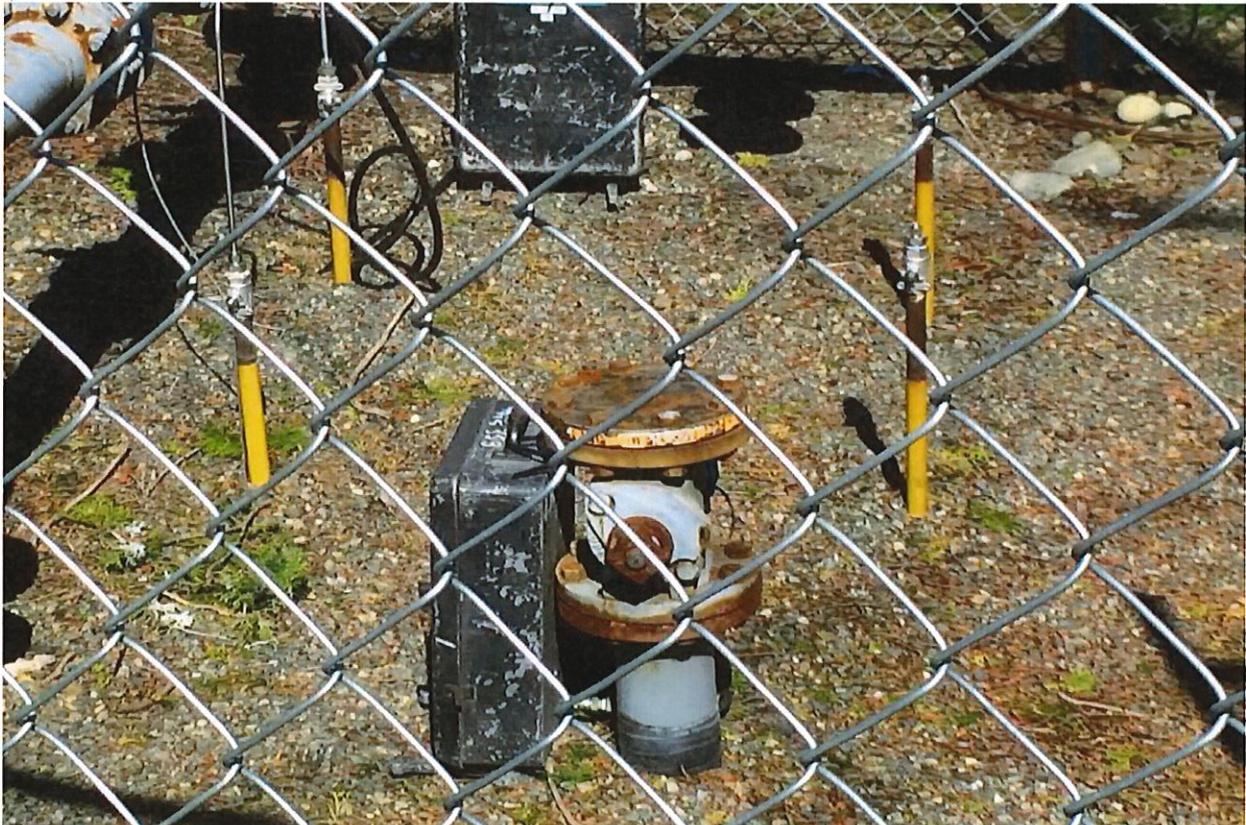
The incident is due to outside force from a driver under the influence of alcohol crashing through the fence of a district regulator station and damaging one of the runs of the regulator.

Photo 4: Regulator Run Damaged by Vehicle

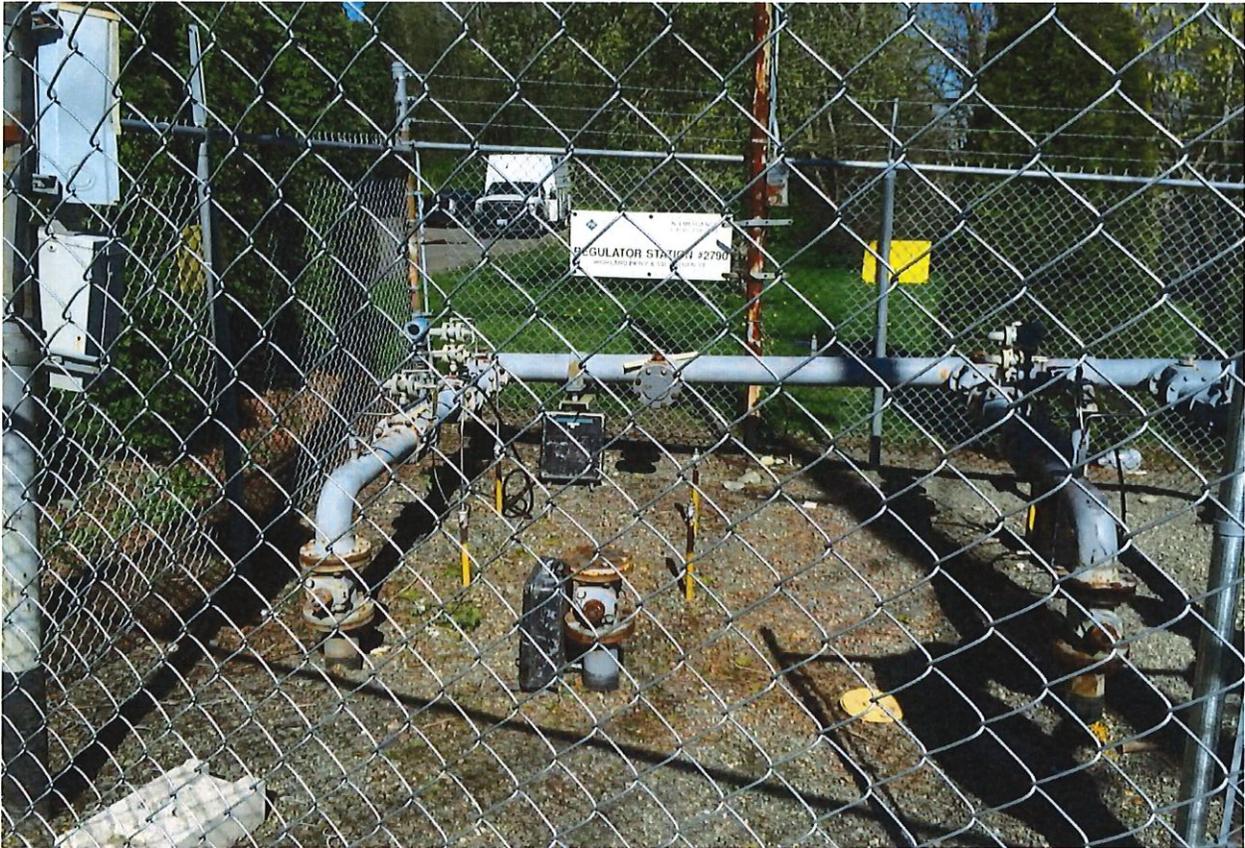
Photo 5: View of Damaged Regulator Run

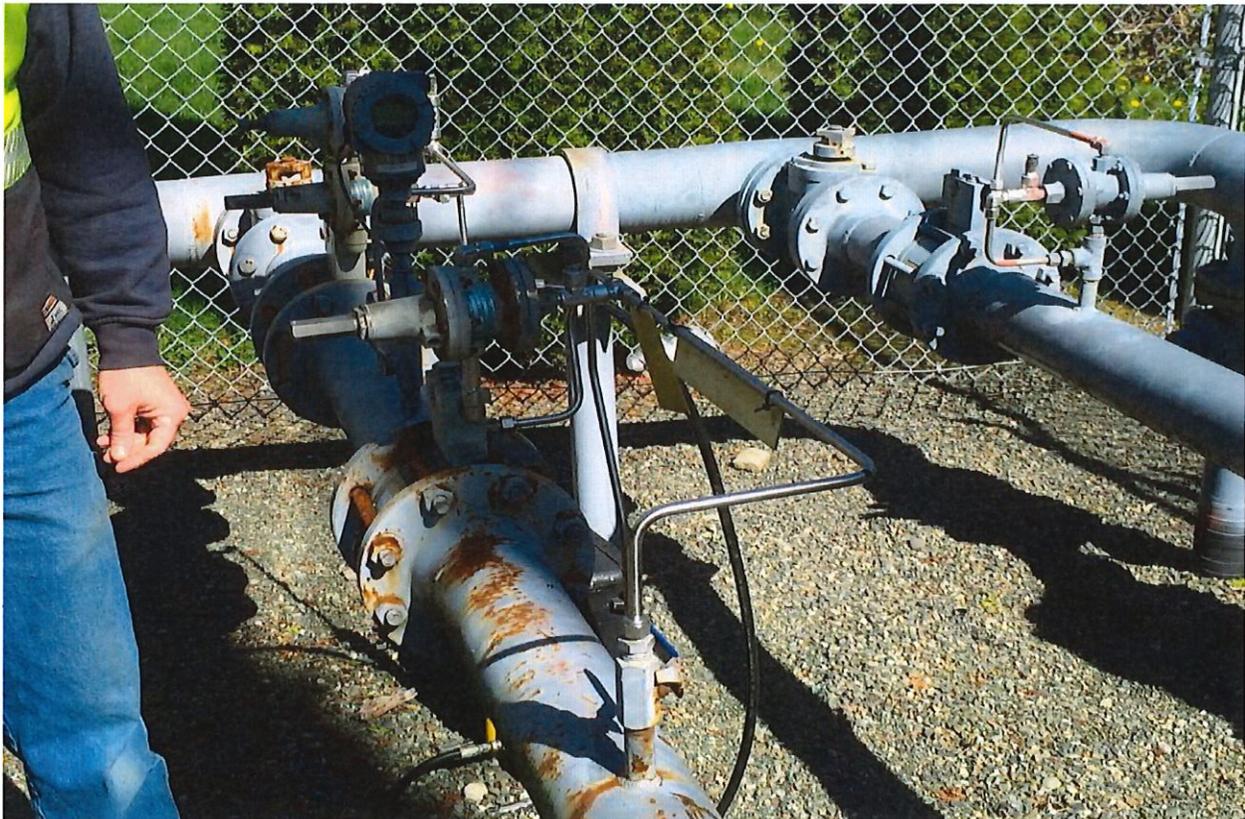
Photo 6: Replaced sensing line

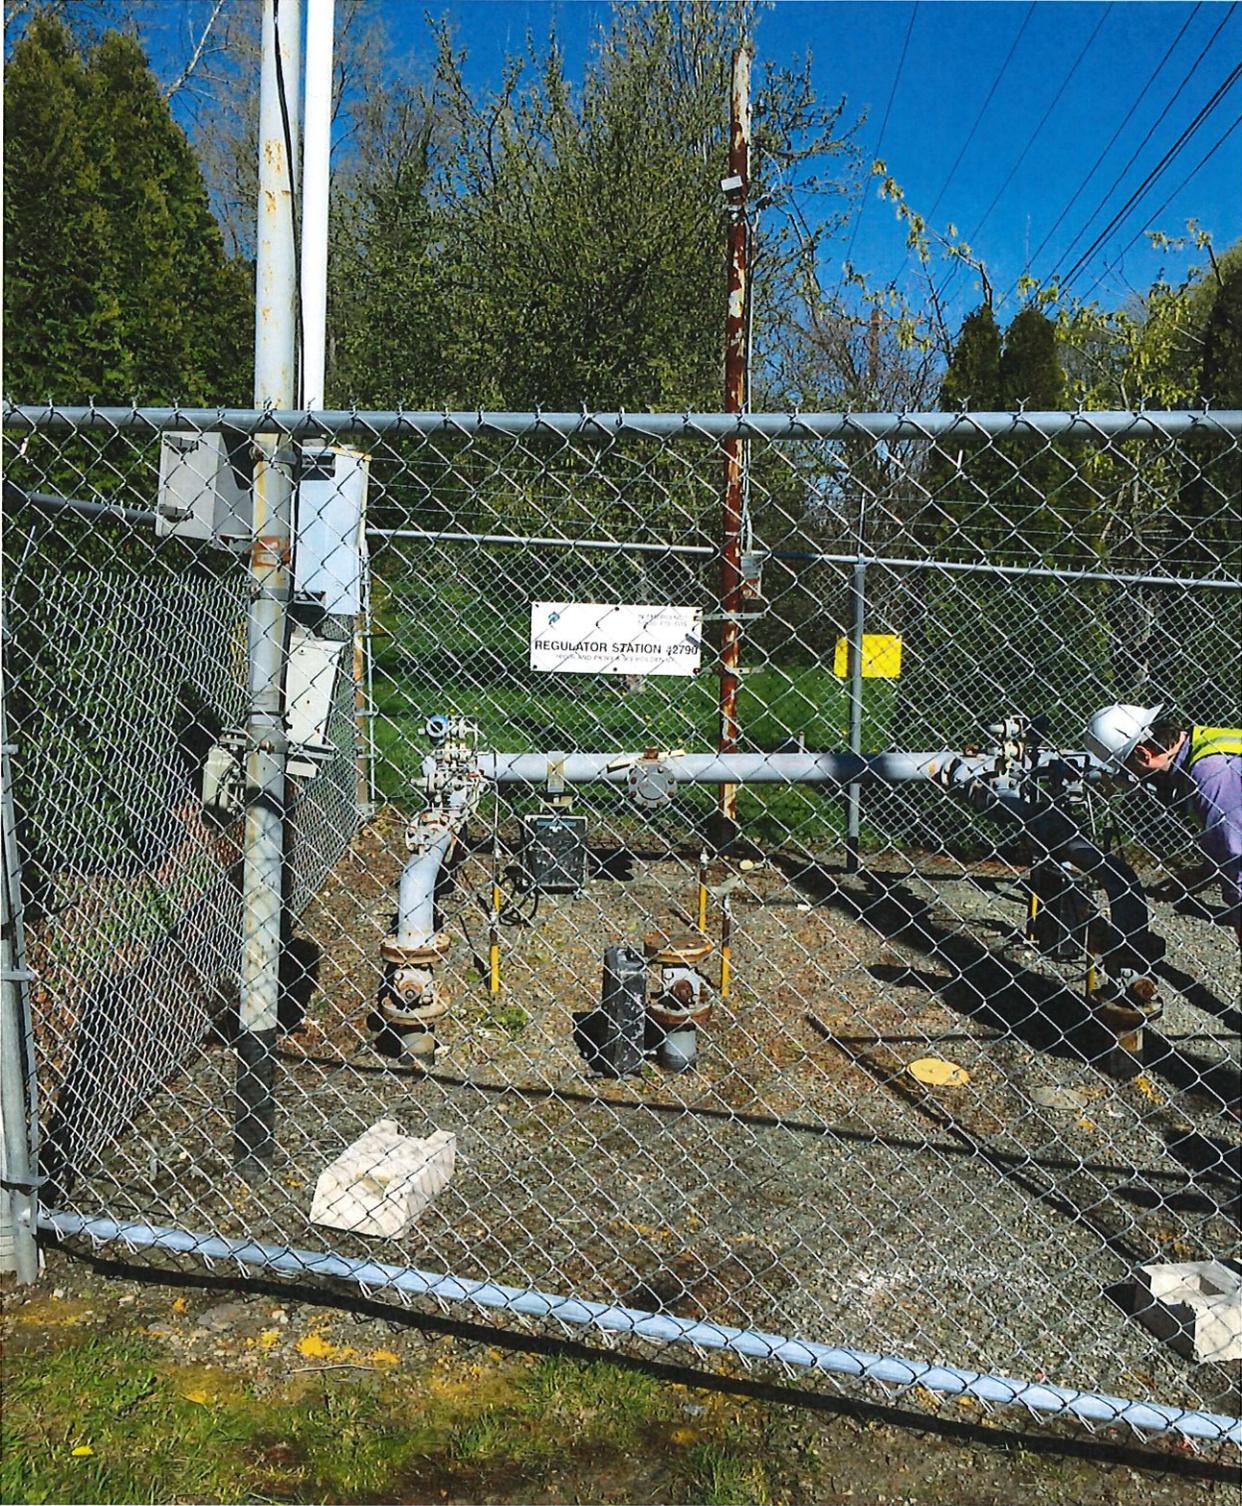
Photo 7: Damaged Regulator Run including Damaged Pole with RTU

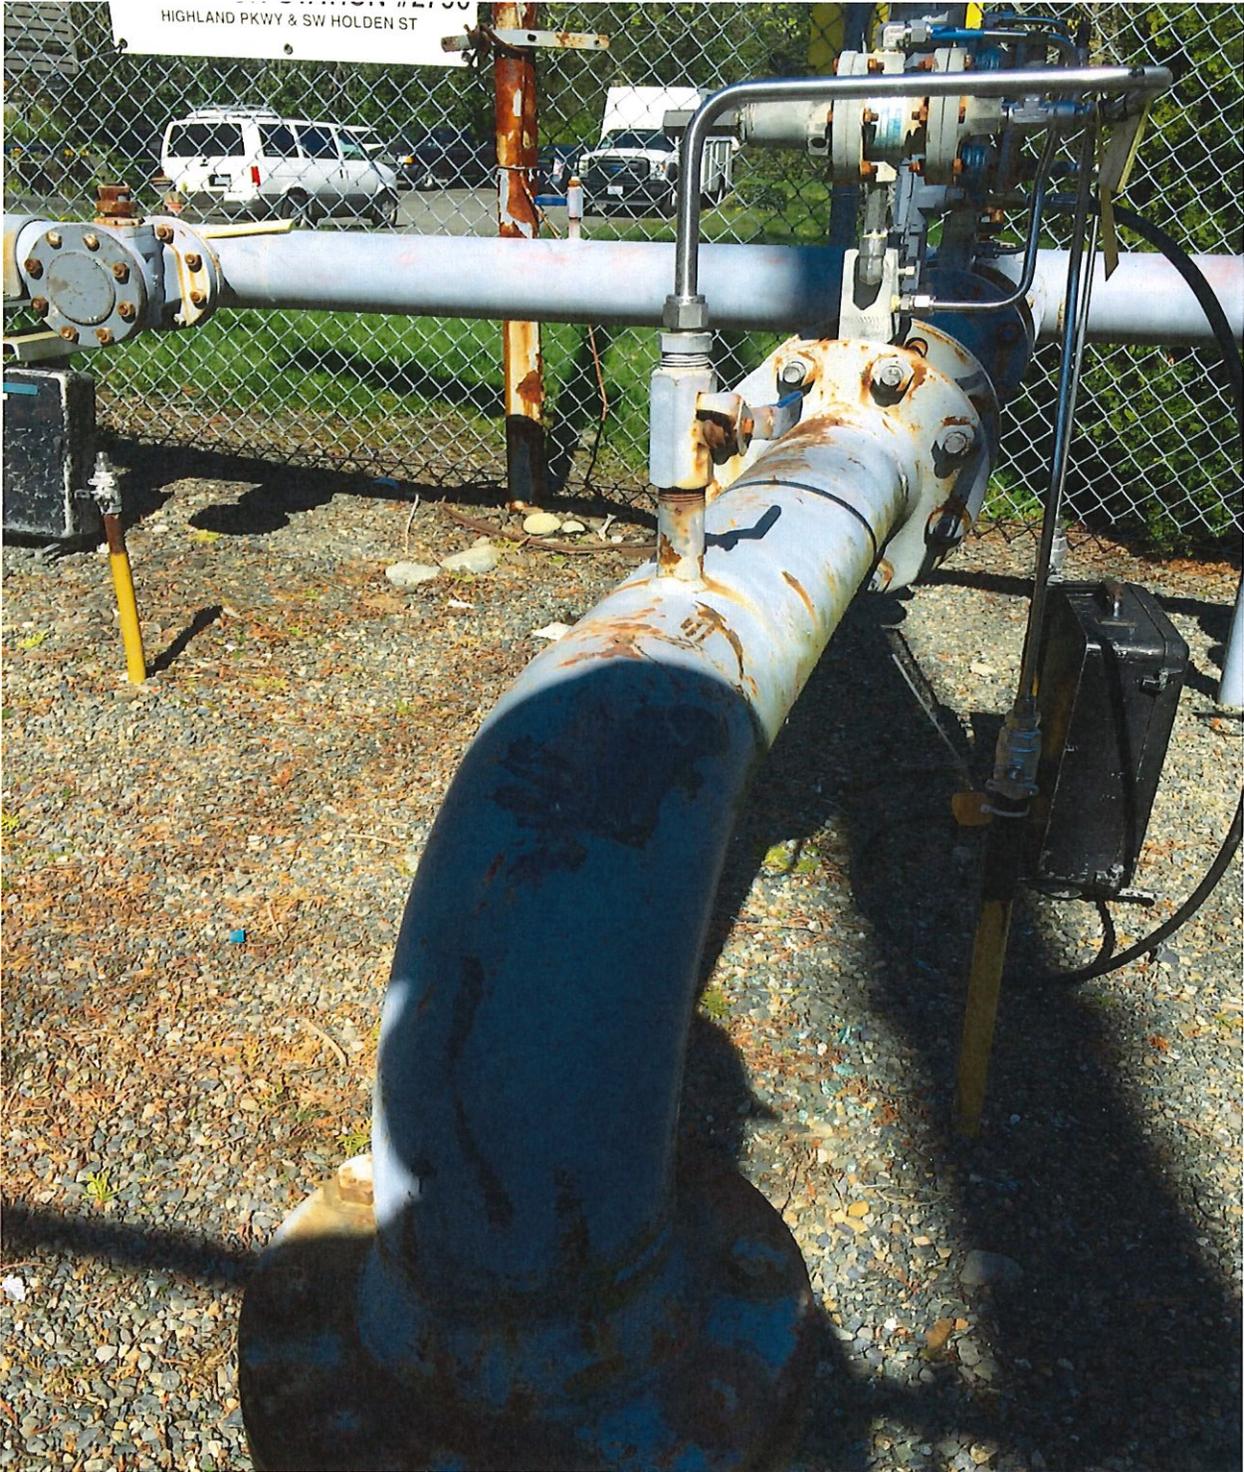
Photo 8: The shown sensing line was damaged and replaced on this run of the regulator

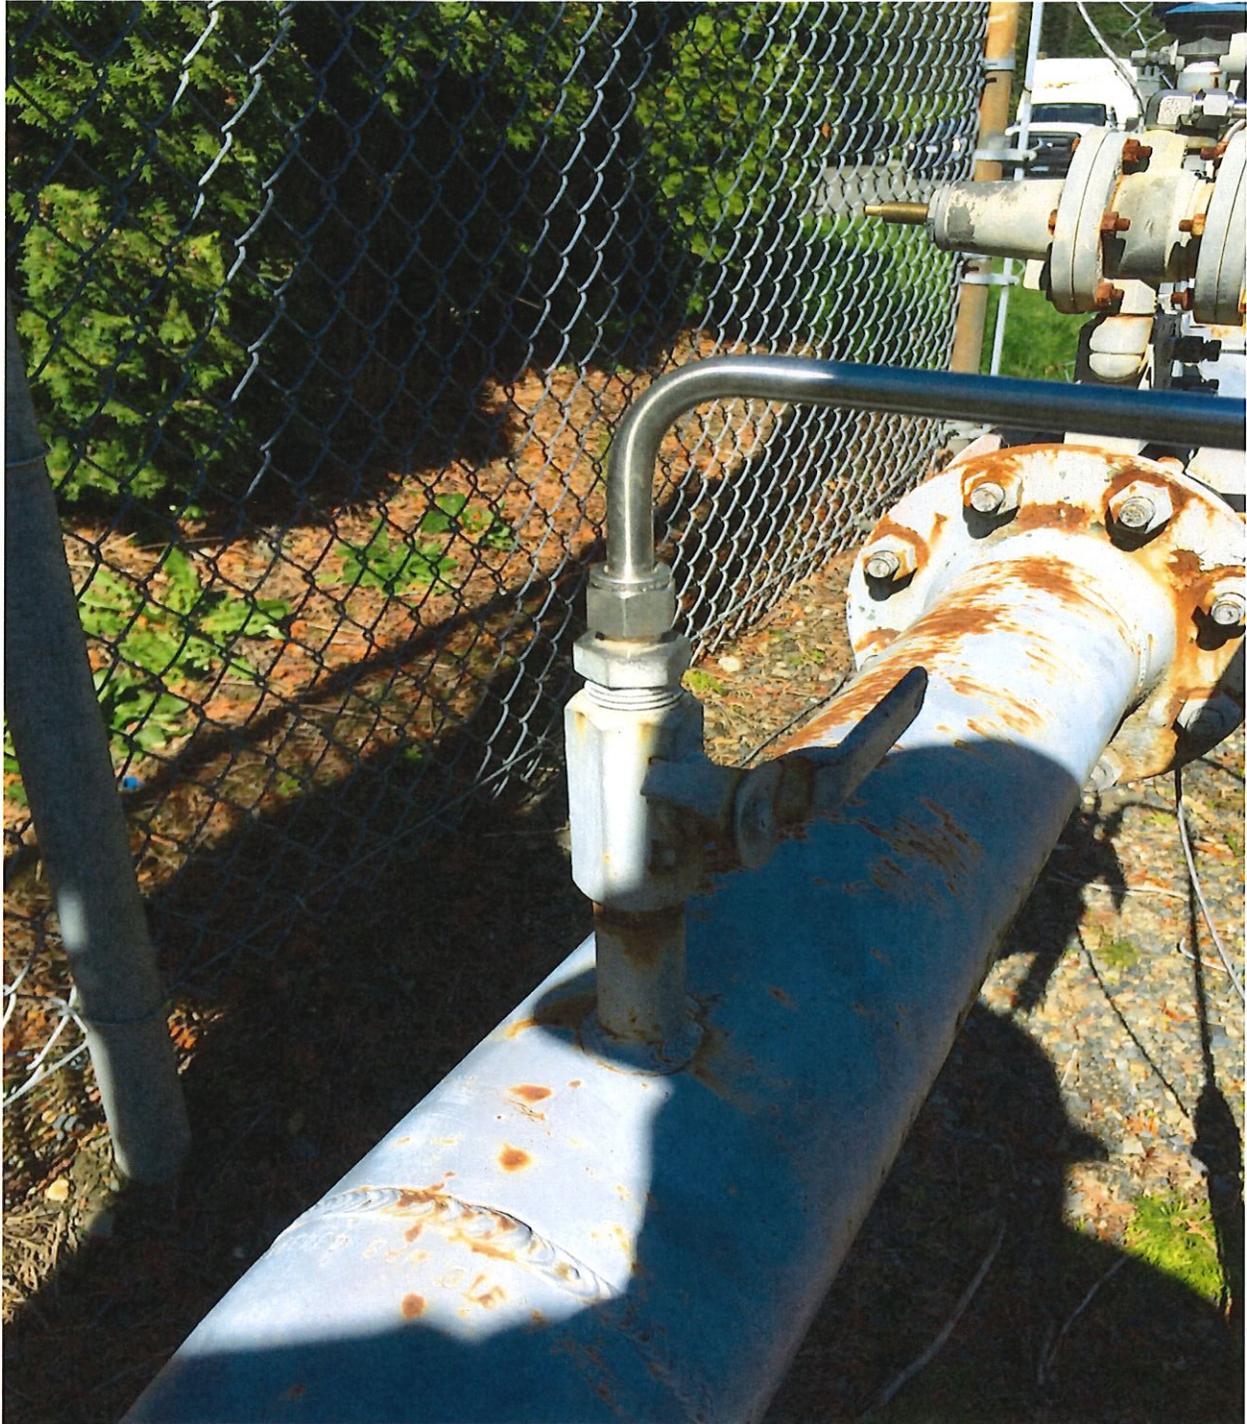
Photo 9: The shown sensing line was damaged and replaced on this run of the regulator
